A "Sweeping" View of Lake Tahoe

By Aaron Zambrana
A to Z Chimney Sweep
Lincoln, California
www.AtoZChimneys.com

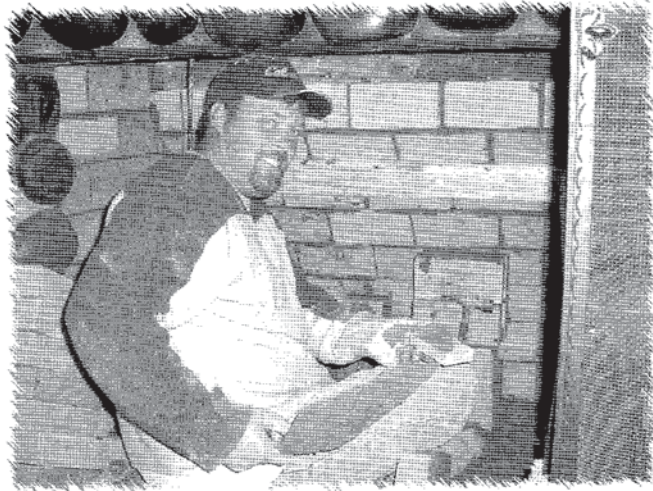
Jared "Hoss" Nielson rebuilding Sunnyside Resort's massive firebox.

We made sure to get an early start in order to wake the slumbering guests to what must have sounded somewhat like a machine gun going off in the lobby. While demolishing the MASSIVE firebox, it was quite fun to watch the groggy (and sometimes irritated) guests peek over the balcony railing to see the jerks making all the racket so early in the morning. Hee hee! Yeah, I guess I never outgrew the sheer joy of things that make lots of noise - big engines, big guns, and demolition hammers. MANLY!

Next, Jared and I rebuilt the firebox, which went well into the evening (to the dismay of the restaurant manager

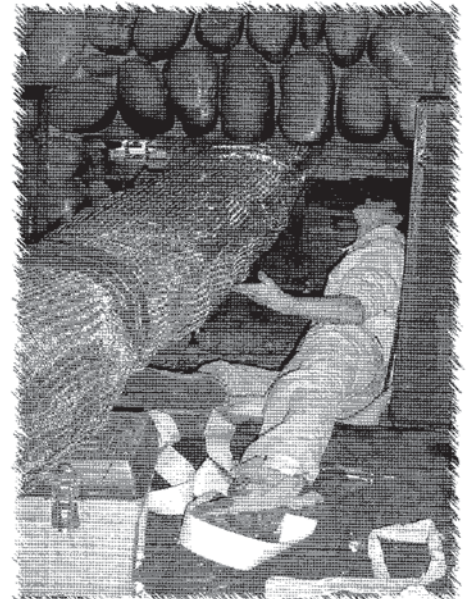
Neal Hooper observes the liner's progress as it is winched up the chimney.

With the firebox demolished and smoke chamber cleaned out, and the wiring set for the Exhausto fan, we were ready to winch the liner into position. We dropped our tin down the chimney to assure a hang-up-free liner ascent [See "The Shoe Horn" by Aaron Zambrana in SNEWS – November 2004], and prepped the liner with ceramic wool insulation and a sleeve of ArmorMesh™.

Winching the liner up from the bottom went smooth as silk, and we soon had secured the liner in position on top and bottom.

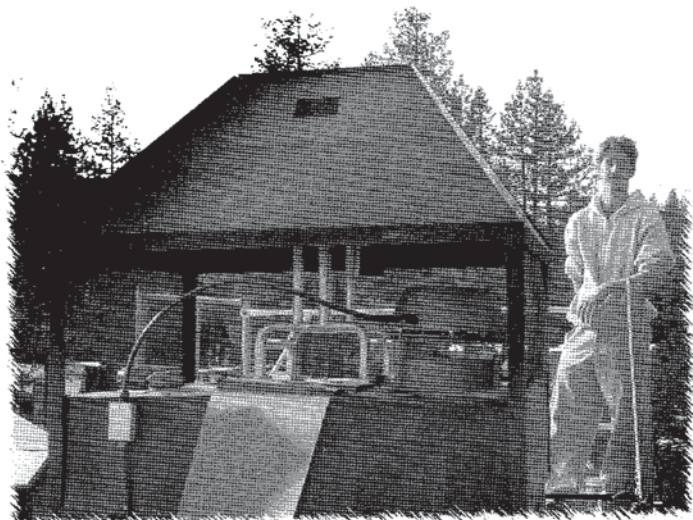
Neal Hooper takes a break from sanding and painting the damaged chimney cap.

While my guys worked on getting the liner into position, I was on my hands and knees in the parking lot fabricating and welding steel parts for the large steel chimney cap perched on top of the chimney. It had

been badly damaged from the heat of the fire, and from the firefighters who ripped it apart in an effort to extinguish the chimney fire.

Neal Hooper worked outside on top sanding and painting the repaired cap while Jared Nielson and I reshaped and parged the massive smoke chamber with eight buckets of Chamber Tech 2000. In addition, the decorative facing was sealed to

With the chimney cap repaired and donning a fresh coat of high

temperature paint, Neal went to work waterproofing the chimney with ChimneySaver Water Repellant. I was very surprised to discover that ChimneySaver overspray can really make your ladder and scaffold rungs VERY SLIPPERY! I almost learned that the hard way.
